**MANUAL  
INSTALLATION - COMMISSIONING  
OPERATION - MAINTENANCE  
DOCUMENT REF. D1236**

A heat detection system using Linear Heat Detection Cable (LHDC) can be installed near the rim seal of a floating roof tank. Due to the rise and fall of the floating roof, electrical connection between detection cable and the control panel can be problematic as standard cable cannot be used.

The Patol Automatic Cable Reeler provides the electrical connections between the LHDC and the Fire Alarm Control Panel.

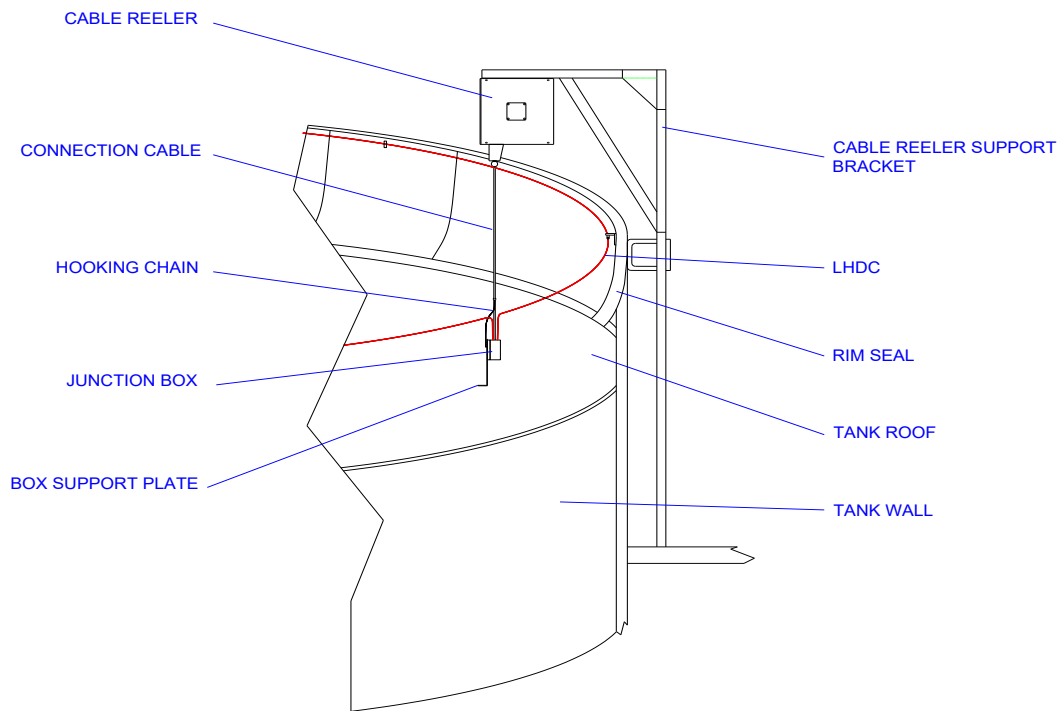
**Figure 1**

To allow the Cable Reeler to be correctly positioned, a support bracket needs to be assembled and fitted to the top of the tank. There is no standard bracket because each tank has different dimensions and each installation will require a customized bracket. It is left to the installation personnel to evaluate the best method of support.

An example is shown in fig.1.

The installation is typical of many others that have already been completed on various storage tanks.

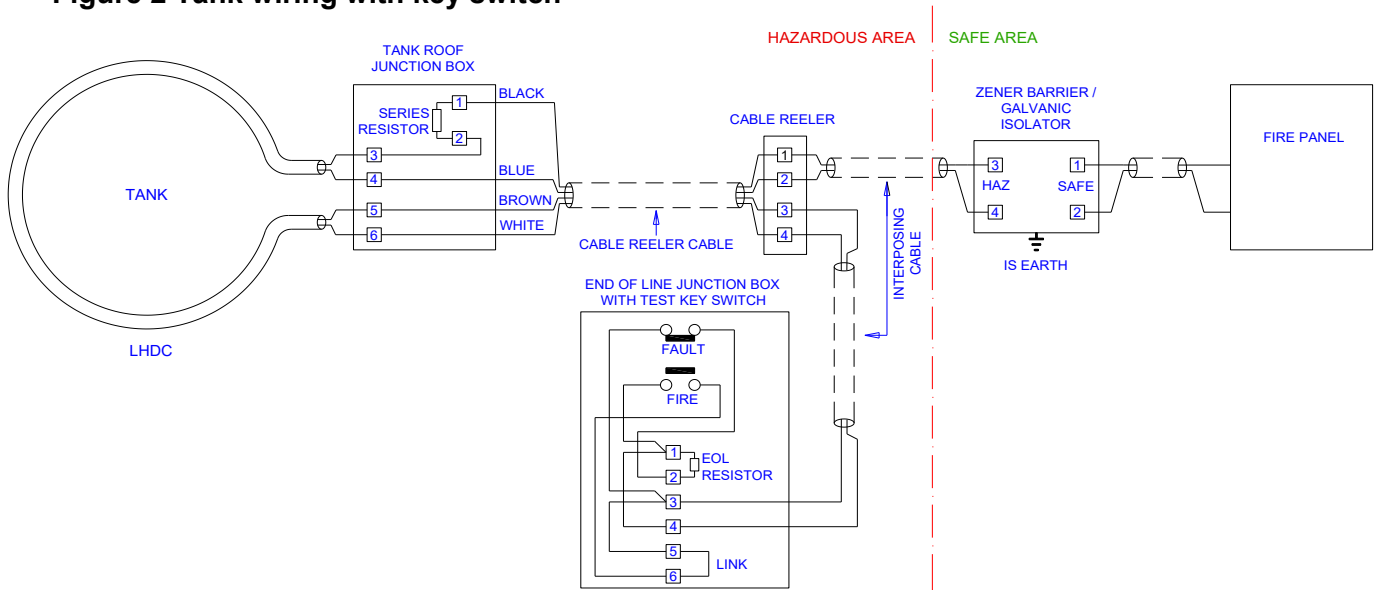
**Figure 2 Tank wiring with key switch**

The Cable Reeler connects the LHDC system that protects the rim seal of floating roof tanks to the Fire Detection Control Panel.

Due to the nature of protection the LHDC is connected to an Intrinsic Safety barrier, ATEX/IECEX Certified, to limit the electrical energy transmitted to the LHDC.

Typical Elements of the plant are:

- Fire Detection Panel, or data acquisition unit to monitor the LHDC (normally located in a safe area).

- An Intrinsic Safety barrier or Galvanic Isolator located in a safe area or in a Certified Ex enclosure.

- Start and End of Line junction box, where the physical connection between the Cable Reeler and the LHDC is made.

- Linear Heat Detection Cable.

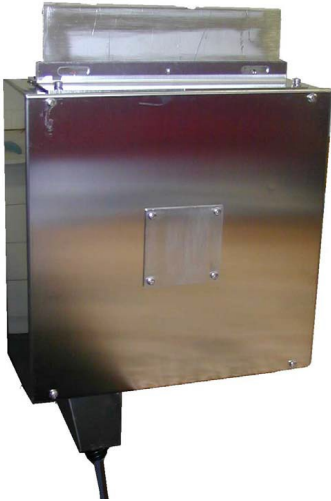
Figure 5

With the cable Reeler in the operating position, the opening of the connection cable is oriented downward, and the Cable Reeler is placed vertical to the connection Junction Box located on the floating roof.

Leaving the Cable Reeler in the operating position, unscrew the screws of the spring pin inspection cover.

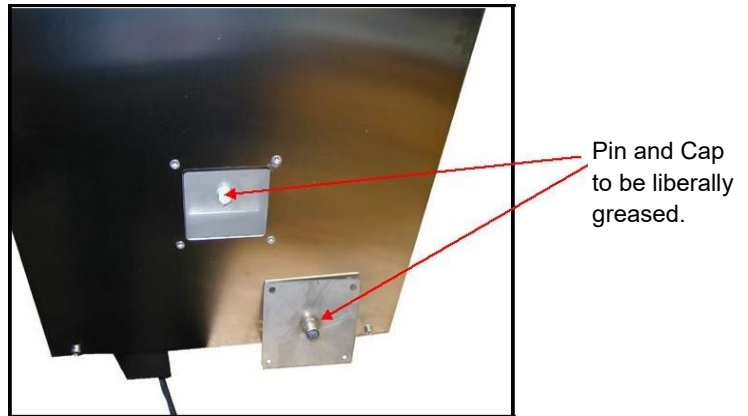
Figure 6

With reference to Fig.6, verify that the spring pin has been well greased. If it is not, put grease on both spring pin and the cap welded on inspection cover.

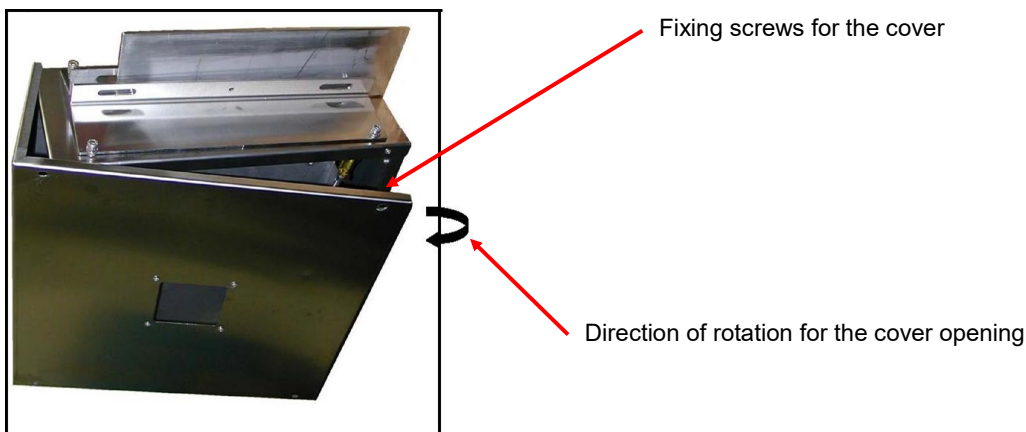
Figure 7

Without mounting the cover of the spring pin, unscrew the locking screws of the Cable Reeler cover, and remove, according to the rotation direction indicated in figure 7

It is not necessary to remove it from its support structure to gain access to the inside of the Cable Reeler. It is not possible to access the cable connection or the internal reel by removing this cover.

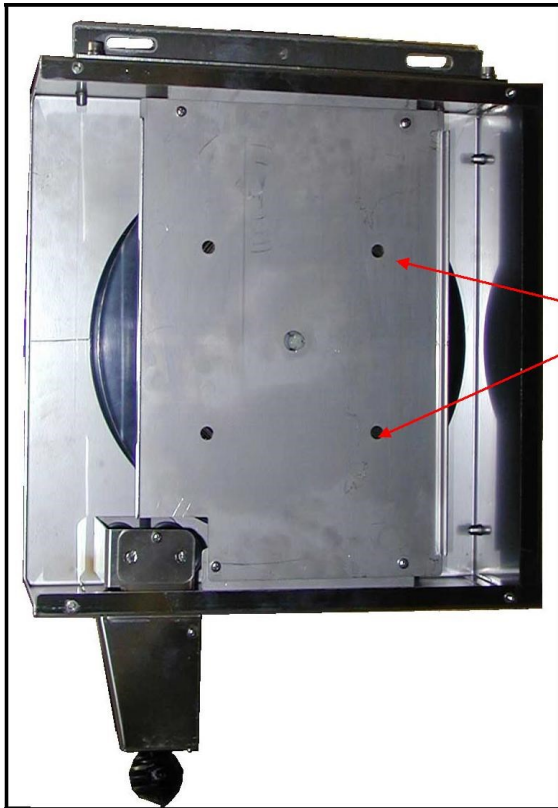
**Figure 8**

Once opened the Cable Reeler looks as shown below, in figures 8 & 9. The rewinding spring is fixed on an internal plate. The internal plate has four holes that are used to verify the presence of lubricant on the spring and, if required, to apply lubrication.

Holes for inspection

**THE CABLE REELER IS NOT DUST OR MOISTURE PROOF. THE SPRING IS MADE OF CARBON STEEL. ALTHOUGH THE SPRING IS PROTECTED, IT IS IMPORTANT TO PERIODICALLY INSPECT FOR THE PRESENCE OF OIL ON THE SPRING.**

**FOR INSPECTION AND THE LUBRICATION, USE THE INSPECTION HOLES.**

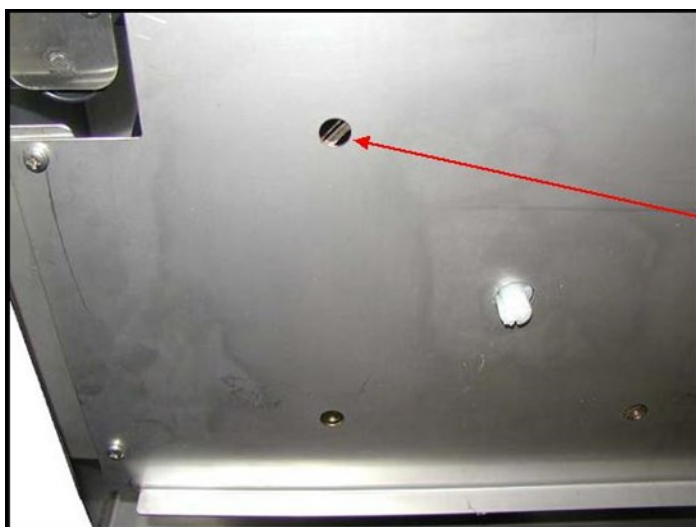
**Figure 9**

Holes for inspection

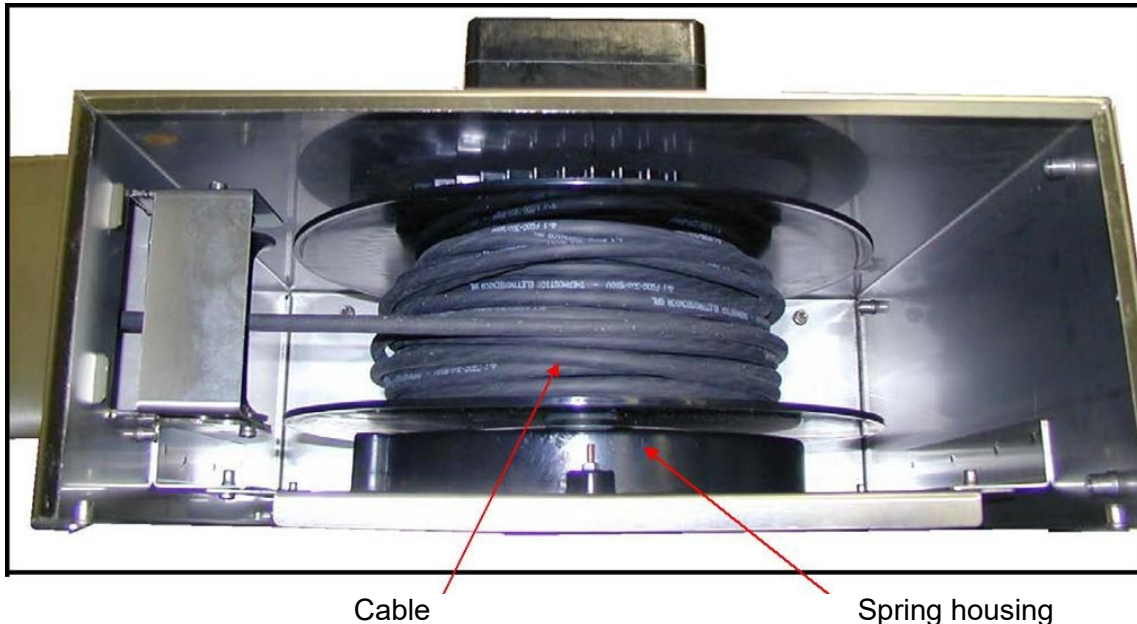
Figure 10

After confirming that the spring and other grease points have been lubricated, perform a visual inspection of the condition of the electrical cable and of the cable exit roller to make sure that the reel and cable can move freely during the winding operation

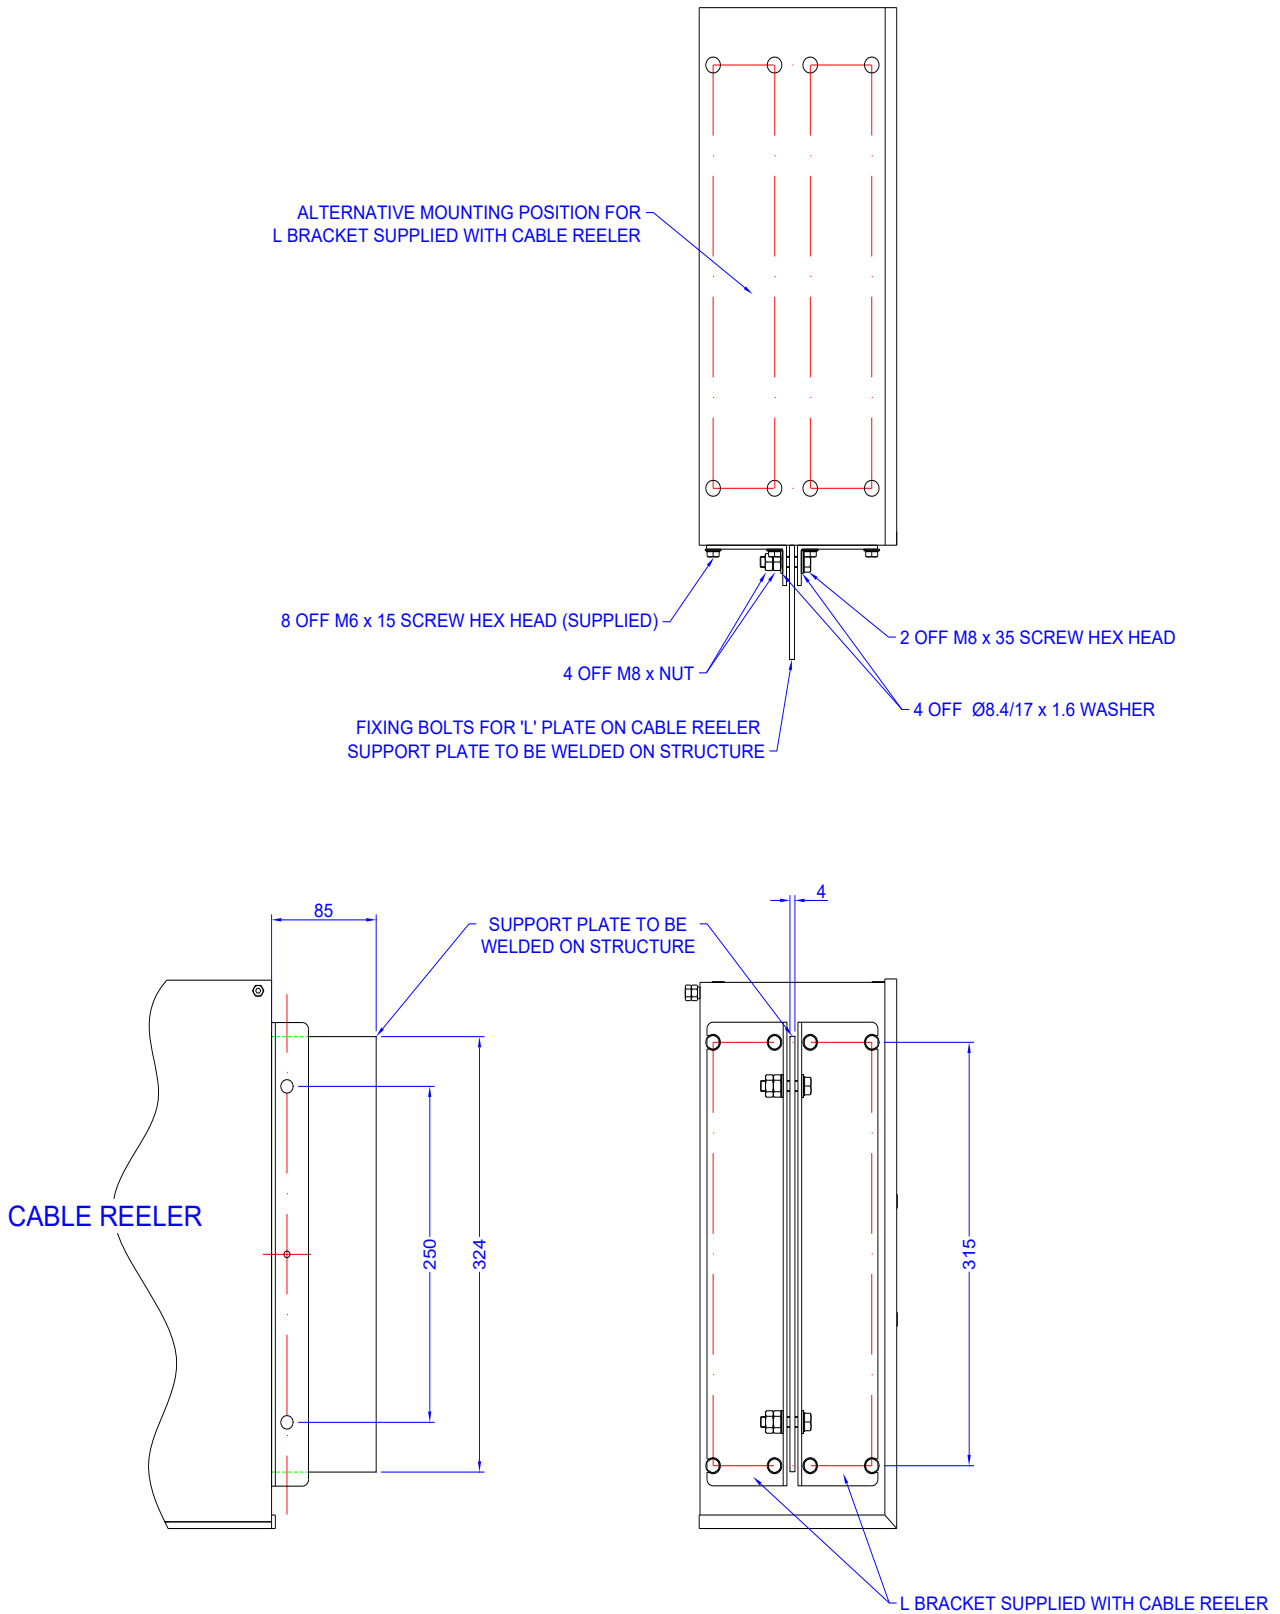
Figure 11. Detail of Connection of Cable Reeler and Support Structure
